**Barton Creek Property Owners Association  
The Estates of Barton Creek Property Owners Association  
Firewise Communities/USA  
Community Wildfire Risk Assessment Report  
May 3, 2005**

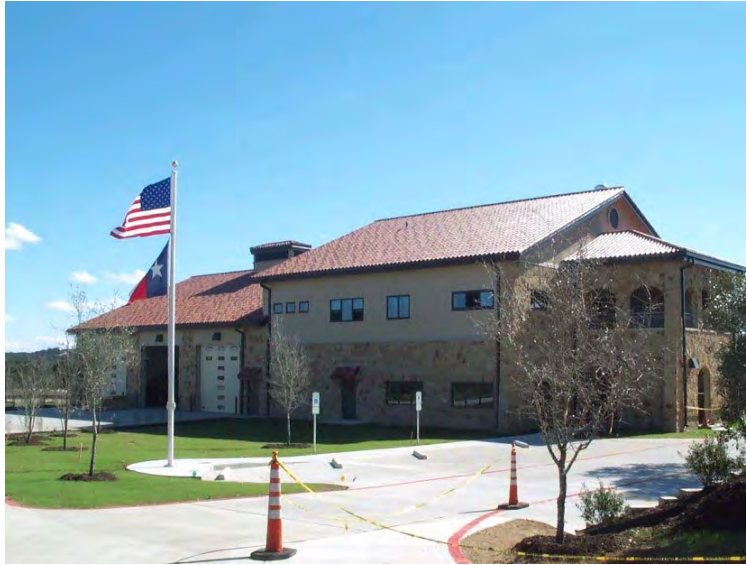
- ✓ Location. All homes in all subdivisions are within a 15 minute response time from the new Travis County ESD 3 - Oak Hill Fire Department station. In many cases, homes are only a few minutes away.

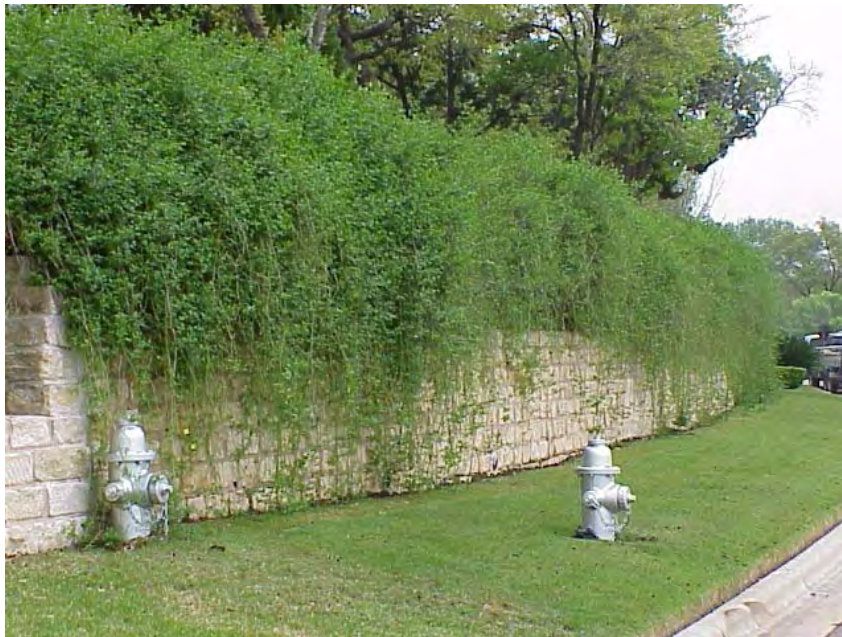
- ✓ Fire Hydrants. All subdivisions and communities have adequate numbers of fire hydrants, which are well spaced, throughout the area.

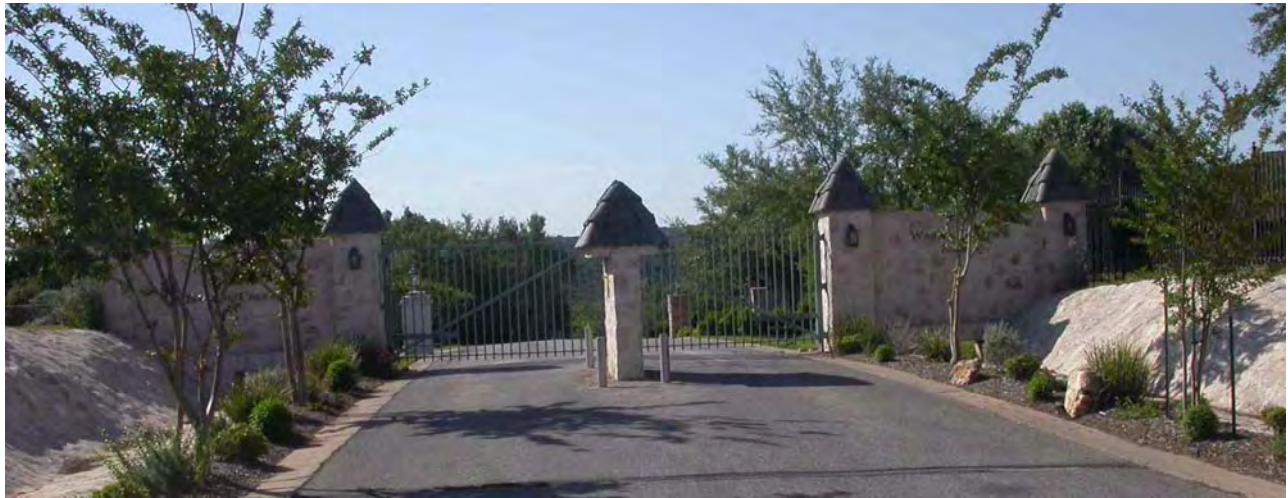
Most neighborhoods are set up in a one-way in/one-way out design, and all neighborhoods, with a few minor exceptions in The Estates and The Foothills, have gated entrances. While this may provide better security by having fewer points of entry for unwanted visitors, it may also inhibit the access to emergency responders (including law, fire and medical). If alternative points of entry can not be created, then gated entrances should be made to easily accommodate the largest emergency response vehicles, namely the structural fire engines. Entry keypads should be designed and located where they will provide the least amount of blockage and interference to these large emergency vehicles.

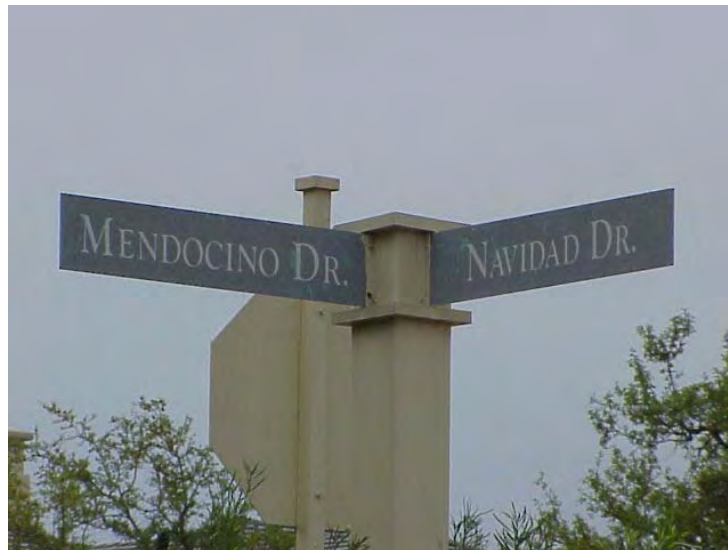
- \* Street Signs. Most neighborhoods (except apartments and condominiums) have metal signs throughout their streets; however, many of these may not be reflective, which makes them difficult or impossible to see after dark or in heavy smoke.

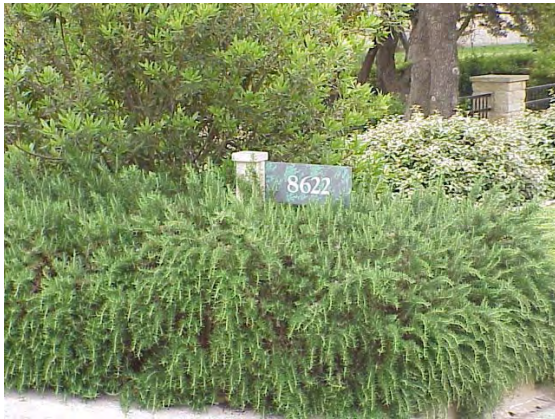
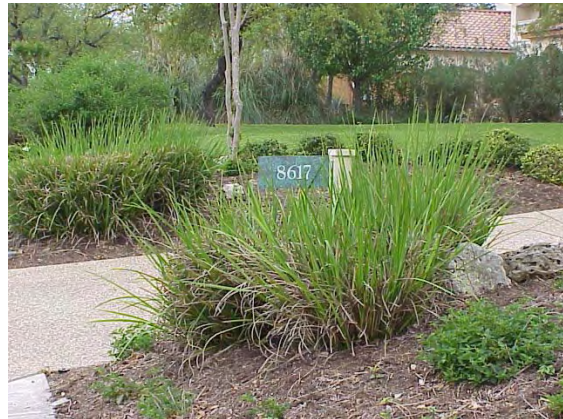
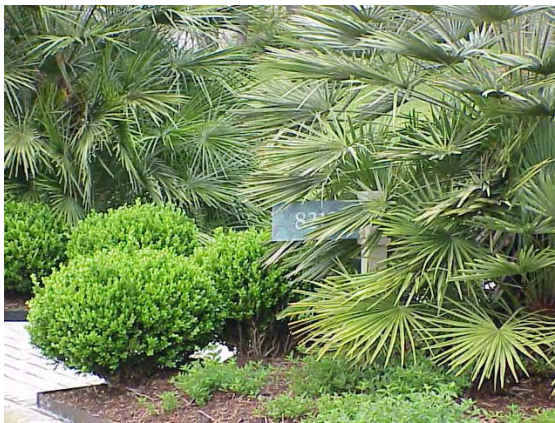
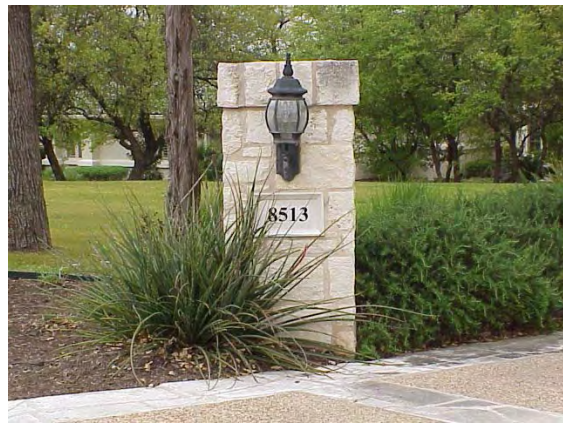
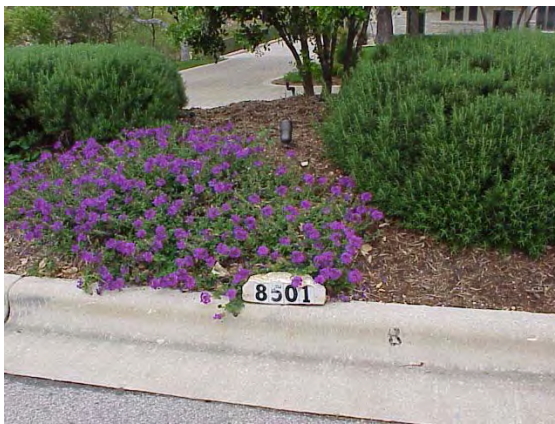
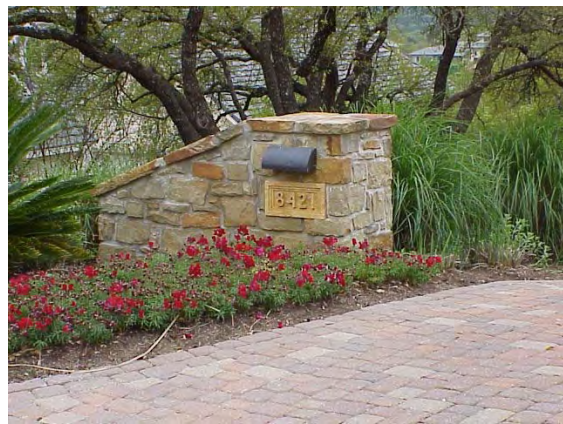
\* Address Signs for Individual Lots. Some neighborhoods have inconsistent locations and/or styles for individual properties. Emergency responders are often slowed down when they have to search for the address signs. Signs should be placed where they are easy to read from both directions down the street. They should also be reflective and placed uniformly throughout the subdivisions. Vegetation should be managed to keep signs visible at all times.

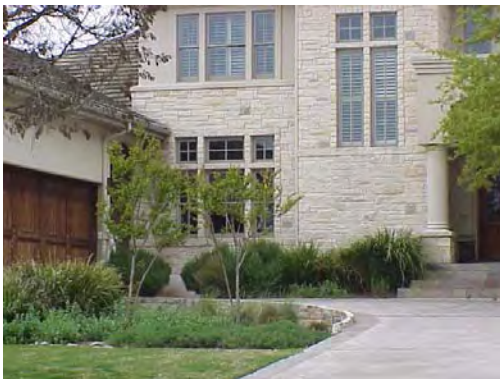
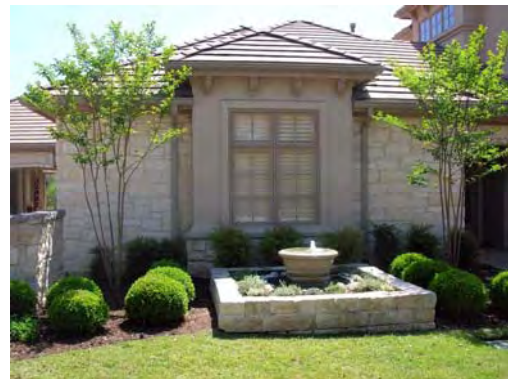
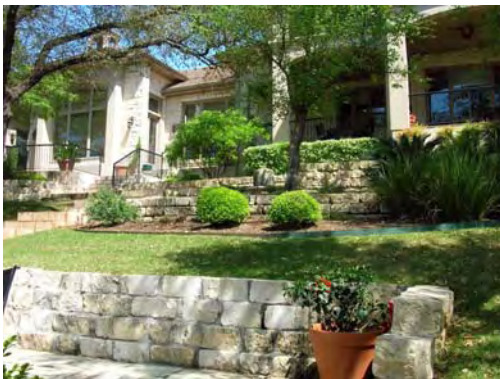
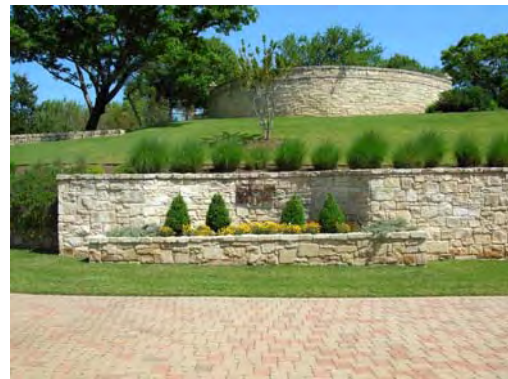
- \* **Plant Arrangement.** While highly flammable plants may still be used in most landscapes, they should be carefully located where their threat is minimized. If possible, they should not be next to structure walls, and certainly not below or next to any windows. They should be planted out in the yard, either as individual ornamentals or in “island” clusters. If grouped under trees, all mid-story limbs, branches, vines, and other vegetation should be removed to create a break in the “ladder fuels”, plants which help the fire move from the ground into the tree crowns. If highly flammable plants are concentrated around tree trunks, the heat could destroy the trees’ cambium layers; thereby killing the trees themselves. This could result in trees falling over into homes and other improvements.

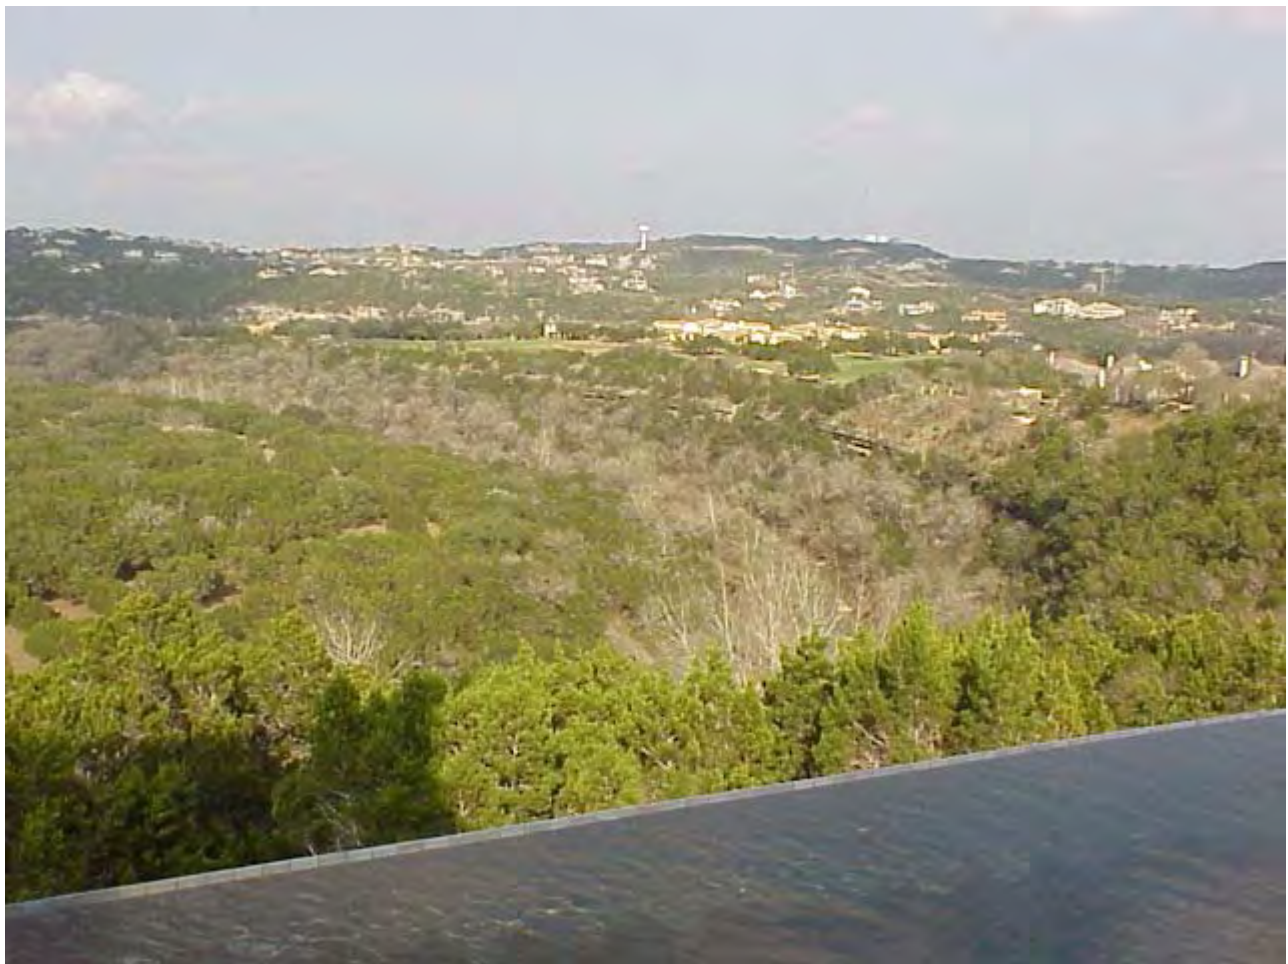
These volatile trees now cover a majority of the slopes in the Barton Creek watershed, where they have matured into a post-climax stand of dense trees and brush. They are creating a continuous crown cover and steadily out-competing the various hardwoods, including the live oaks and post oaks that are trying to hang on. The adult hardwoods, along with native grasses and forbs, are competing with the junipers for nutrition and moisture from the soil. Any new and young seedlings are being consumed by the deer population, whose food source is continually reduced by the encroaching junipers.

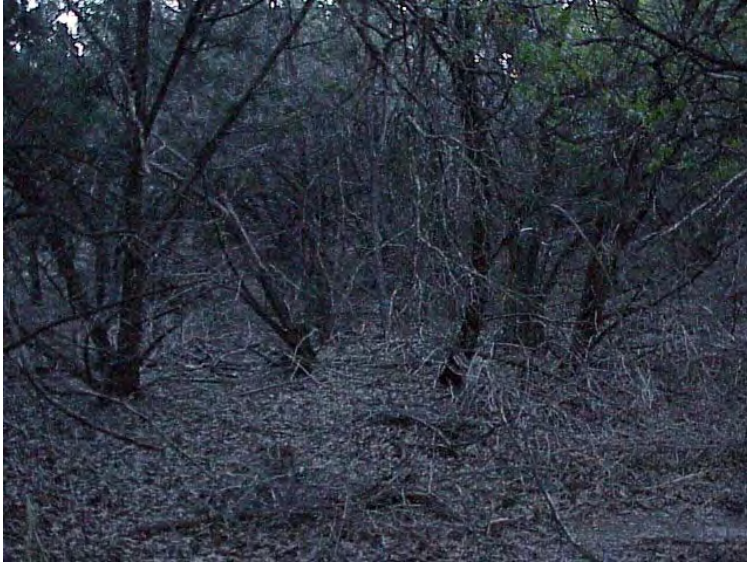
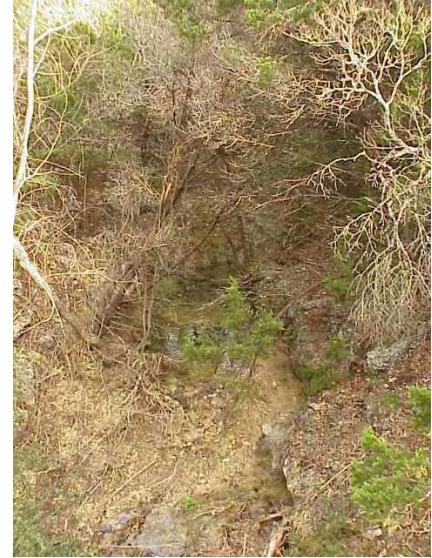
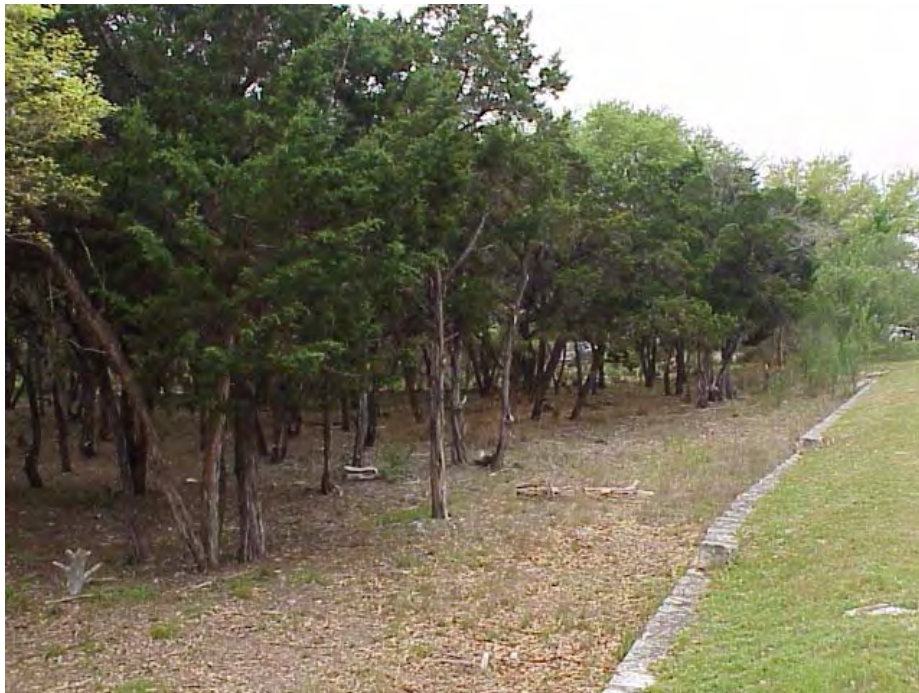
These unmanaged mature trees contain a high percentage of dead material, often referred to as deadwood. At the very least, any mature trees within 50-100' of any structures and improvements should have all deadwood removed, and the trees should be limbed up to 6-10' from the ground. This will eliminate the majority of ladder fuels that would transport the fire from the ground into the tree canopies, transforming a “surface fire” into a “crown fire”.

If mature junipers are serving as vegetative screens between properties, neighbors should consider replacing these volatile plants with alternative species with lower flammability ratings.

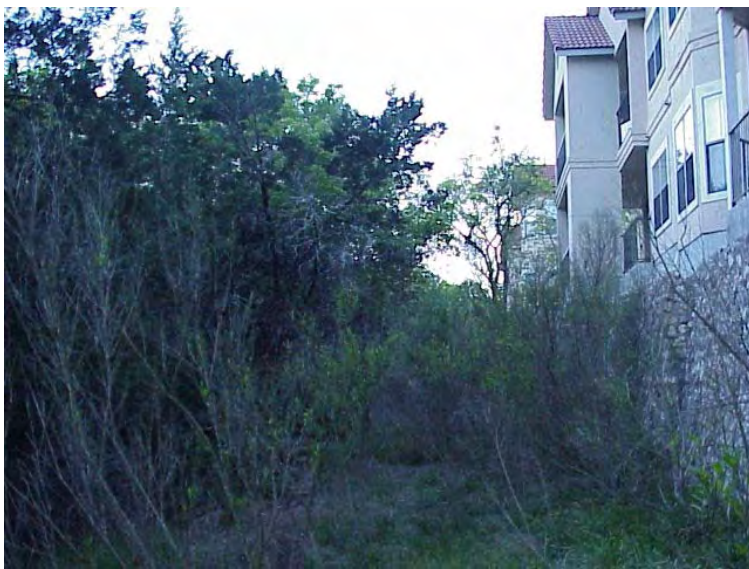
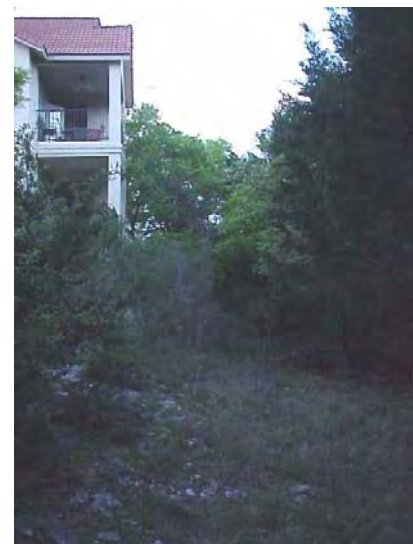
Concerns: Heavy old-growth juniper vegetation along entire eastern perimeter with some vegetation coming within 30 feet of buildings.

Recommendations: Create a minimum 30-foot clearance (50+ feet preferred) between junipers.

Aggressively thin stand of junipers (leave the oaks and other hardwoods) and limb remaining trees 6-10' from the ground.

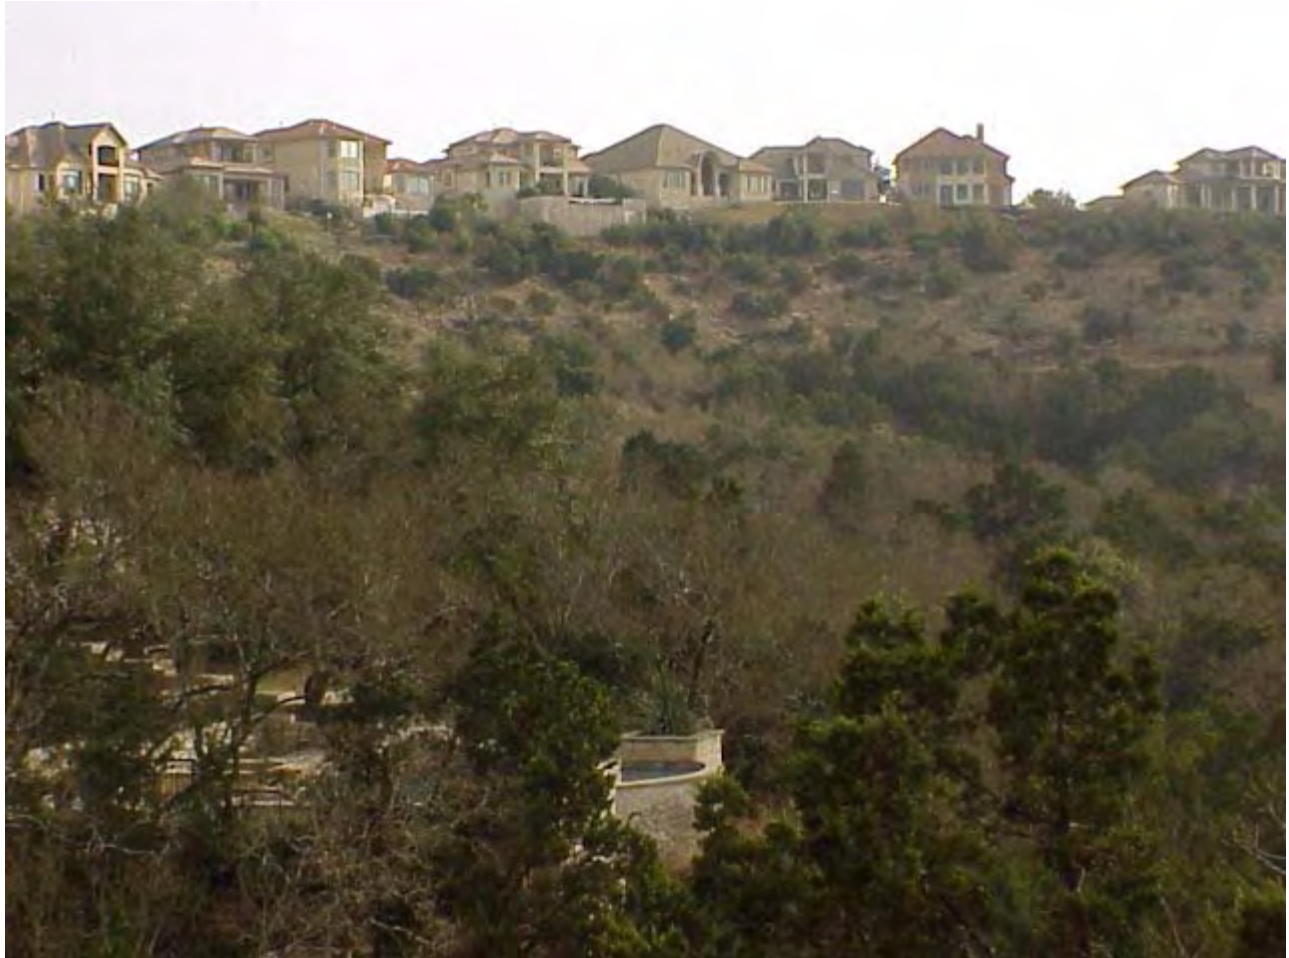
Concern: Junipers exist on slopes below homes, but somewhat thinned. Still present some threat to homes above them.

Recommendation: Remove trees within 50' down-slope from homes and limb up other trees within 200' from ridgeline 6-10' from the ground.
